Hazardous Materials Release From Railroad Tank Car With Subsequent Fire at Riverview, Michigan July 14, 2001

**Hazardous Materials Release
From Railroad Tank Car With
Subsequent Fire at
Riverview, Michigan
July 14, 2001**

**NTSB/HZM-02/01
PB2002-917002
Notation 7400A
Adopted June 26, 2002**

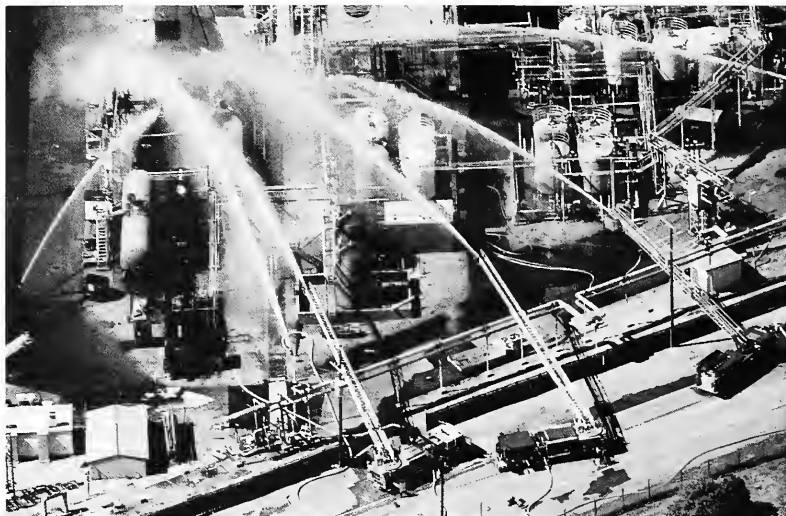
Figure 3. Overview of accident site and emergency response.

At 4:09 a.m., the leaking methyl mercaptan ignited, completely engulfing the tank car in flames. The Riverview fire chief, who witnessed the ignition, said the ignition

resulted in a fireball that extended an estimated 200 feet into the air. When the fireball occurred, the Riverview fire chief requested mutual aid from the surrounding communities. Riverview Fire Department responders began applying water to the tank cars involved in the fire and to the adjacent tank cars to keep them cool. (See figure 3.) Units from the Wyandotte, Trenton, and Brownstown Fire Departments, and the Downriver Mutual Aid HAZMAT Team⁶ responded.
